J Longfellow Consulting M.A., R.P.A., R.P.H.

May 28, 2014

Subject: Historic Building Survey, 418 Carrillo Street, Santa Rosa, California

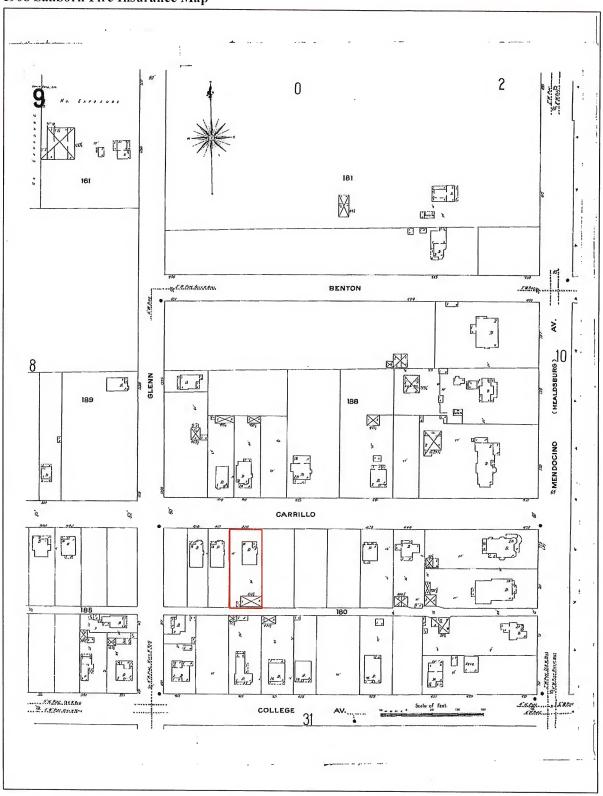
1908 Sanborn Fire Insurance Map

The 1908 Sanborn map depicts the house as one-story, wood shingle roof with an above ground basement, a wooden shingle-roofed porch on the northeast corner and a stable at the rear of the lot abutting an alley. The 1908-1950 Sanborn shows a two-story, two-flat dwelling with a composition roof. Both the roofs on the two story front porch and the one-story back porch were also composition. A

414 Carrillo Street

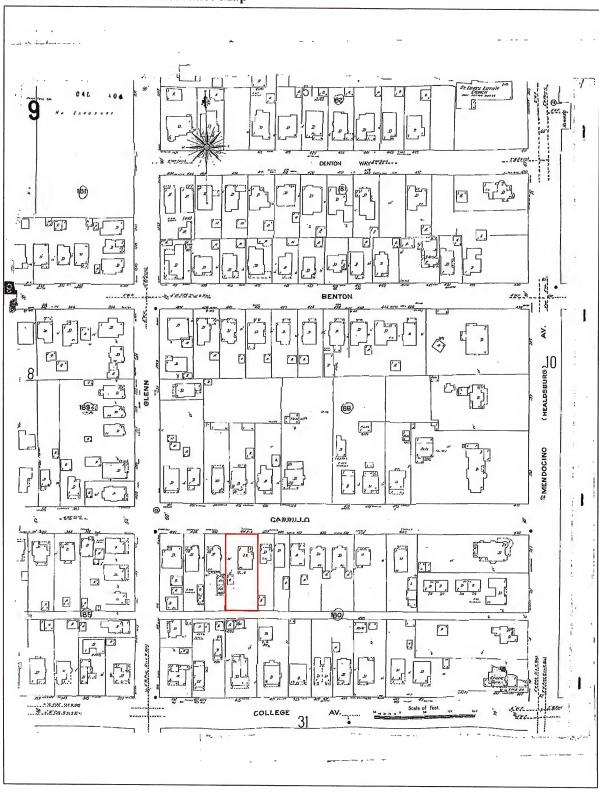
1908-c1950 Sanborn Fire Insurance Map

414 a and b Carrillo Street

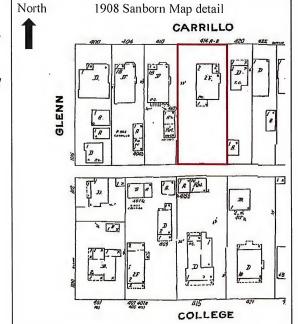
The residence has been so profoundly altered that it no longer resembles its historical form. The single remaining historical element is its redwood drop siding, which is now completely hidden under aluminum siding. The resource was originally a one-story single family residence; the basement was converted to a separate flat c. 1947. The 1936 lot line adjustments on the east and west have narrowed the parcel by three feet on each side. The form of the original wood shingle roof is unkown but was very likely not the hot tar style of its current iteration. Remodeling beginning in the 1950s divided the lower flat into three apartments, removed the garage, and added a brick stairway with wrought iron rails to the upstairs flat entry. Although other contemporary houses in the neighborhood have been altered to varying degrees, few others have been so modified that they have lost all integrity of historic feeling. It is a non-contributor to the Ridgway Historic District and the City of Santa Rosa has determined that the property "is ineligible for designation through local review" |
